BROTHER Standard Gauge RIBBERS

The Brother KR830 and KR850 are almost identical. The major difference is in the carriages, but they are interchangeable between the two ribbers.

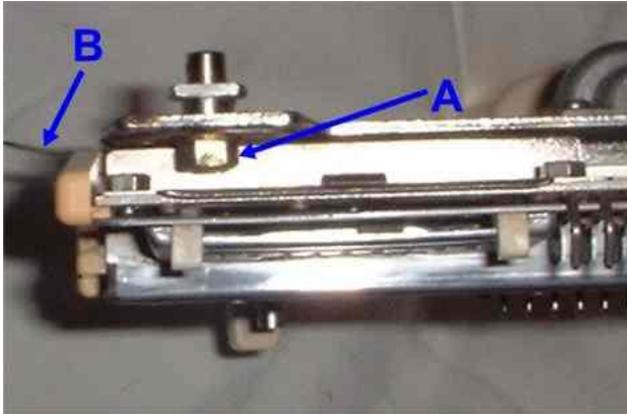
Height is the commonest problem. Set the ribber at H5 and draw out a few main bed needles at each end. There should be a small gap between the needles and the sinker posts of the ribber. Brother's recommendation is just over 1mm. That is about the thickness of a c.d.

To alter height, lower the ribber and use the spanner provided with the ribber or an 8mm open ended spanner to loosen nut 'A'. Lift the ribber into normal working position. The lever 'B' can then be moved to change the height of the bed relative to the brackets. Check on both ends of the bed that you can just pass a c.d. between the needles and the ribber sinker posts. I usually tighten the nut from the side, not moving the ribber until it is fixed. The nut needs to be secure, but excessive force is not required to hold it.
